Contract #: 04-0120F4Cty: SF/ALA Rte: 80 PM: 13.2/13.9File #: 69.28**WELDING INSPECTION REPORT****Resident Engineer:**Pursell, Gary**Address:** 333 Burma Road**City:** Oakland, CA 94607**Report No:** WIR-001001**Date Inspected:** 07-Dec-2007**Project Name:** SAS Superstructure**OSM Arrival Time:** 630**Prime Contractor:** American Bridge/Fluor Enterprises, a JV**OSM Departure Time:** 1730**Contractor:** Zhenhua Port Machinery Company, Ltd (ZPMC), Changxing Island **Location:** Shanghai, China**CWI Name:** Fu Yu Hong**CWI Present:** Yes No**Inspected CWI report:** Yes No N/A**Rod Oven in Use:** Yes No N/A**Electrode to specification:** Yes No N/A**Weld Procedures Followed:** Yes No N/A**Qualified Welders:** Yes No N/A**Verified Joint Fit-up:** Yes No N/A**Approved Drawings:** Yes No N/A**Approved WPS:** Yes No N/A**Delayed / Cancelled:** Yes No N/A**Bridge No:** 34-0006**Component:** OBG Second Weld Trial**Summary of Items Observed:**

1 UT verifications on the PJP for the Second Weld Trial

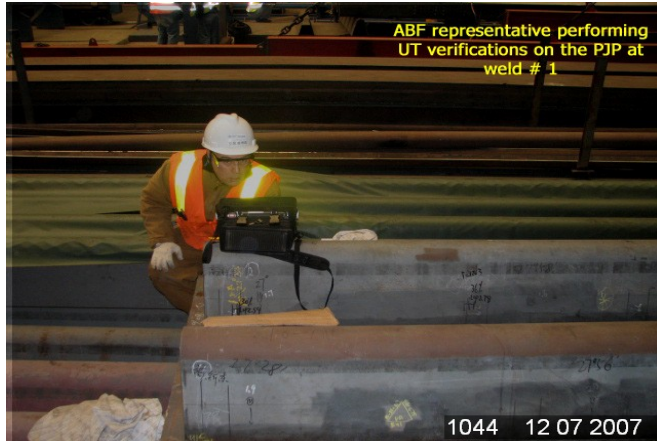
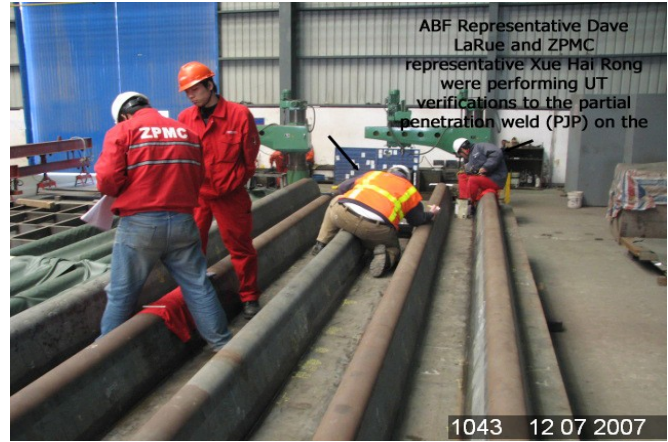
The QA inspector observed Mr. Art Peterson performing 100 % UT verifications on the partial penetration joint (PJP), at the 12 mm U-rib # U-75 weld joint # 5.

The QA inspector performed 100% ultrasonic testing (UT) evaluation after Mr. David LeRue on the partial penetration joint (PJP) at the 12 mm U-rib # U-75 weld joint # 6. The QA inspector concurred with the locations that Mr. David LeRue marked on the steel however the rating of indications are listed on locations 32 thru 35 on table below.

The QA inspector performed UT verifications to the weld # 9 from the U-rib U-05 after Mr. Xue Hairong. The QA inspector concurred with the locations where ZPMC found the indications, however the rating of the indications are listed on the table below, locations 39 thru 46.

Note: The QA inspector observed that Mr. Xue HaiRong obtained higher reflected amplitud for the indications present on weld # 9.
